## IDAHO CONSERVATION PARTNERS WORK TO FIX WEISER RIVER LEVEES

By Steve Stuebner

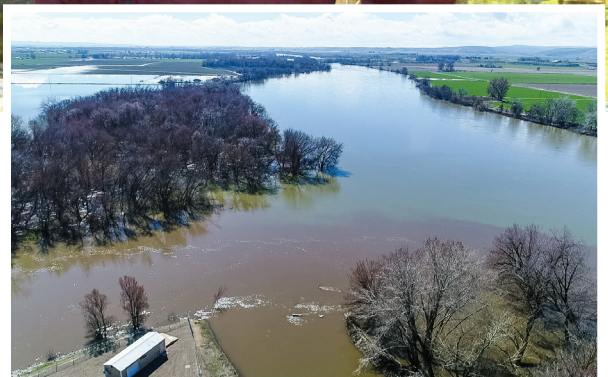
*Flooding persisted for months after the initial event.*

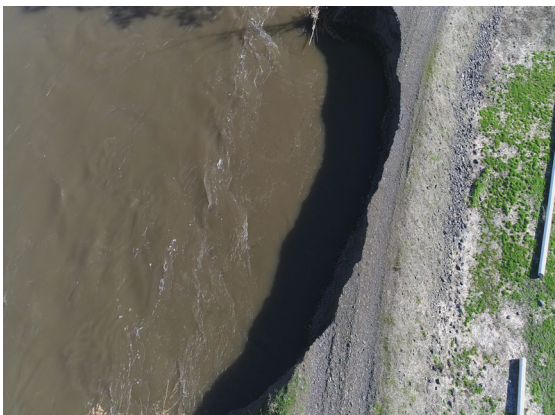
Through the survey, Hickey found numerous levees that had been damaged or breached in a 10-mile reach of the river. At a site upstream of the Unity Bridge, the river had cut away the levee like a knife.

“Well this used to be complete roadway, and the river has cut in during the ice and flood,” Hickey says. “It’s eroded this levee away, and it’s kind of typical of what’s happened in several places where it’s done that.”

Flood waters washed away a levee road on the Weiser River. Photo credit Snake River Horizons, 2017.

Above the Unity Bridge, Hickey worked with a contractor to restore the levee along the Weiser River and integrate a series of rock barbs in the riverbank to slow down the water and protect the bank from the strong river current and future ice flows. Willows will quickly grow back on the river bank and help anchor the levee.

An aerial view shows how the contractor followed the engineering design provided by Bill Lillibridge. The river current hits the toe of the rock barbs, slows down, and forms an eddy behind it the rocks, thereby reducing streambank erosion overall.

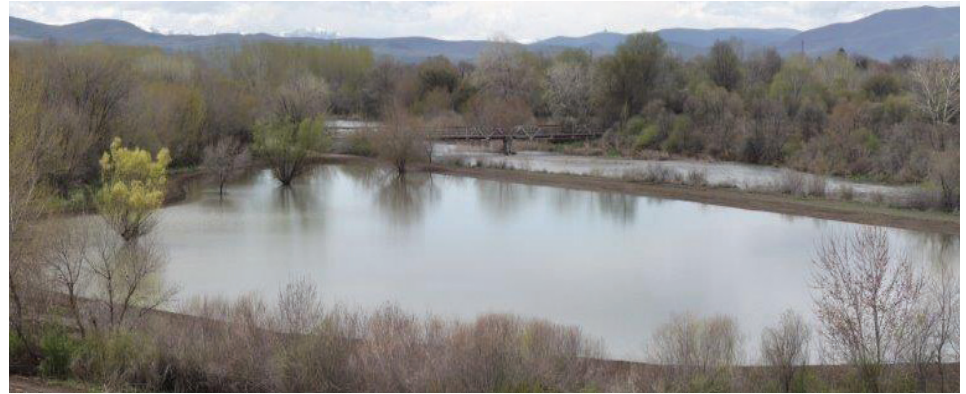
Several years ago, the Weiser River Soil Conservation District created a large wetlands area to filter out sediment from an irrigation canal as part of a \$456,000 Section 319 water quality project funded by the Idaho Department of Environmental Quality and the Environmental Protection Agency.

“The whole dike in here has been damaged in several areas,” she said. “The trees have been shaved off, as if they never existed, you’ve never been able to see through here.”

Several years earlier the Weiser River SCD created a sediment-capturing wetlands project that was inundated by flooding in 2017.

The Payette Ditch Company also helped clean up the sediment ponds adjacent to the levee, so the water quality project will function correctly.

“This wetland was put in to reduce the sediment and the phosphorous and the nitrogen before it dumped into the Weiser River. And clean up the Weiser River for the TMDL established by EPA,” Lukehart explains. “The integrity of the pond is fine. It’s fixable ... definitely fixable.”

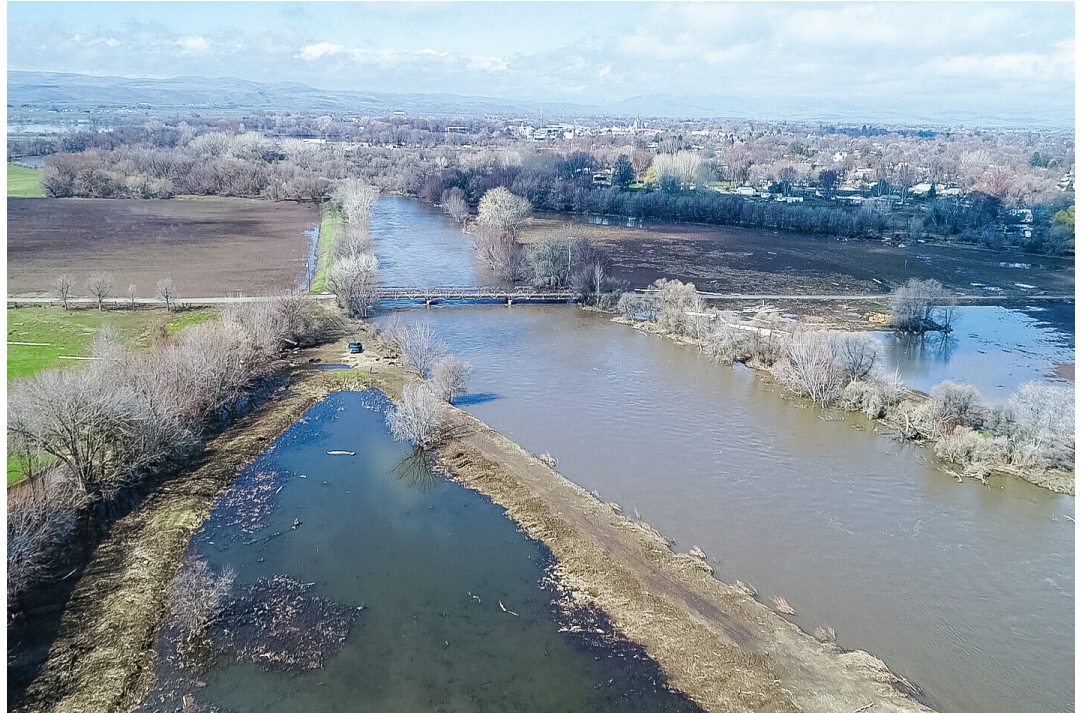
Closer to Weiser, aerial footage showed the damage to the sediment-retention ponds and the levees by Twin Bridges.

*Aerial footage captured by Snake River Horizons shows the flooding, damaged sediment-retention ponds, and levees by Twin Bridges.*

By the Twin Bridges area, Hickey worked with a contractor to restore the levee on both sides of the river, following the Commission’s engineering designs.

“He took all the material in the ponds, came in with a cat and cleaned it back up, filled the hole, had 19 loads of this big rock and put some gravel on top to keep a nice road bed and bring it back up to grade,” he said.

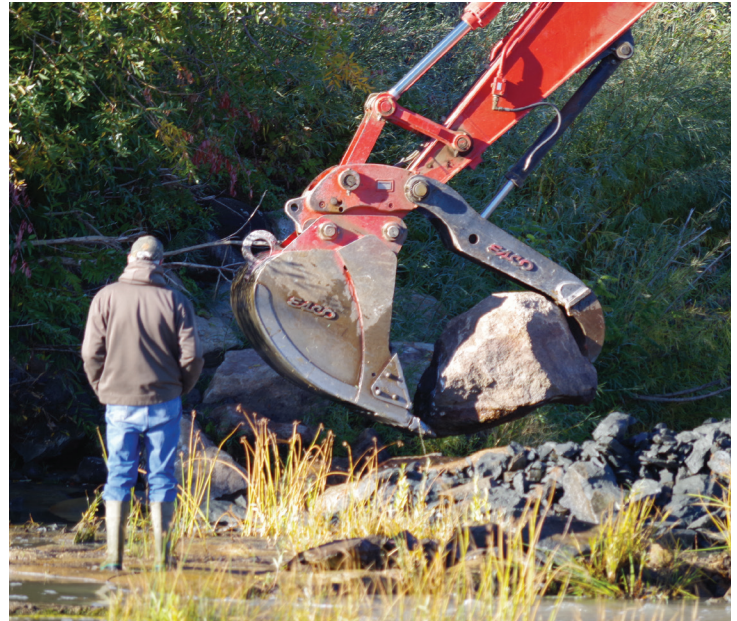
*Hickey directs a contractor installing rock bars to protect against future floods.*

Hickey has been working with a contractor to install rock barbs along this section of the river. The rock barbs protect the bank, and slow the river down as it passes through the rocks and willows. “It makes a dead pool, when the water comes down and hits it, and then it slows down until it hits another one, and the sediment drops out,” he said.

The flood district has installed a whole series of rock barbs in this area to protect the vital river bank next to the Sunnyside Canal.
